NASA Contractor Report 2754

Real-Time Testing of Titanium  
Sheet and Extrusion Coupon  
Specimens Subjected to Mach 2.7  
Supersonic Cruise Aircraft  
Wing Stresses and Temperatures

Tjerand Lunde  
Lockheed-California Company  
Burbank, California

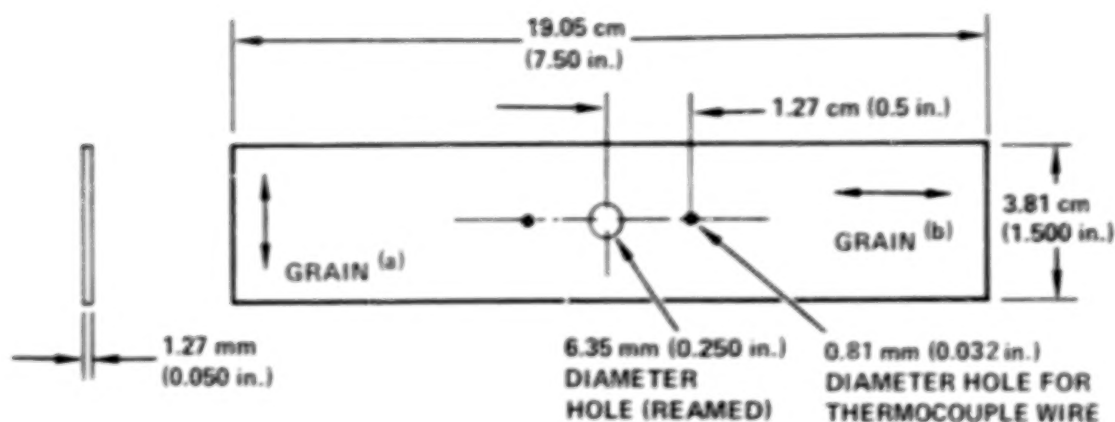
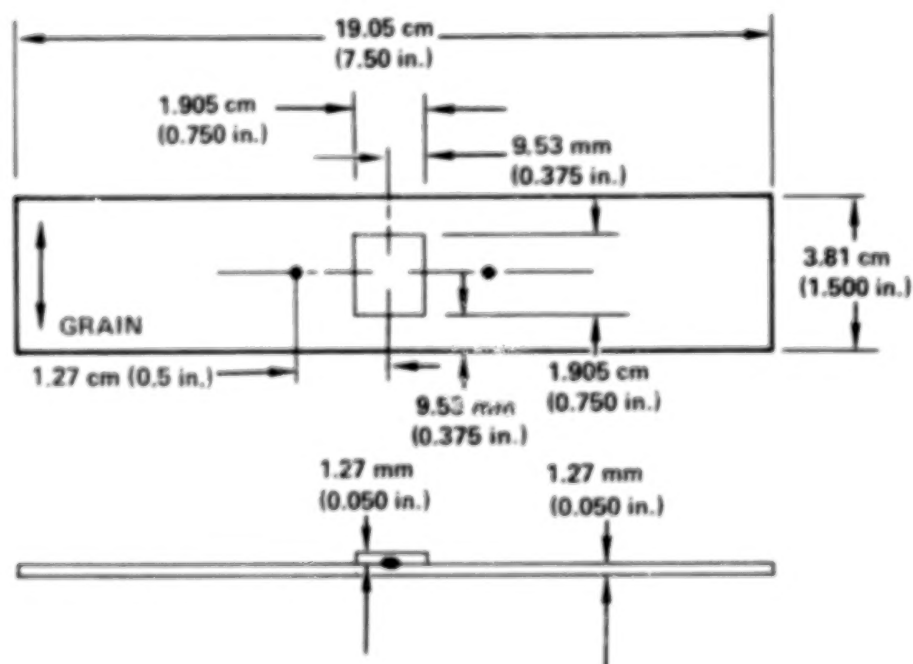
Figure 2. - Test specimen geometries.

(a) CENTER-NOTCHED FATIGUE SPECIMEN.

(b) FATIGUE SPECIMEN WITH SINGLE SPOTWELD DOUBLER.

Two types of specimens were tested in this program. These were thirty center-notched specimens and six single spotweld specimens having the geometries shown in Figure 2. Center-notched specimens were made from all the six materials and the single spotweld specimens were made from the duplex-annealed Ti-8Al-1Mo-1V sheet. The extrusion specimens were taken from the flange material of T-extrusions as shown in Figure 3. A minimum of 0.76 mm (0.030 inch) was machined from each surface of the extruded material. During the manufacture of the specimens, it was found that the material thicknesses were not exactly 1.27 mm (0.050 inch). Some were thicker and some were thinner. In order to compensate for this, the specimen widths were adjusted such that the net areas were as closely as possible the same as required to produce equal stresses under load.

The cracked real-time specimens which were taken out of the testing machine were failed statically in tension. The net area strengths of these specimens are given in Table 13. The failure strengths are from 68 to 94 percent of the room temperature ultimate strengths. The sheet specimens were tested in the transverse grain direction, and the extrusion specimens were tested in the longitudinal grain direction (see Figure 2).

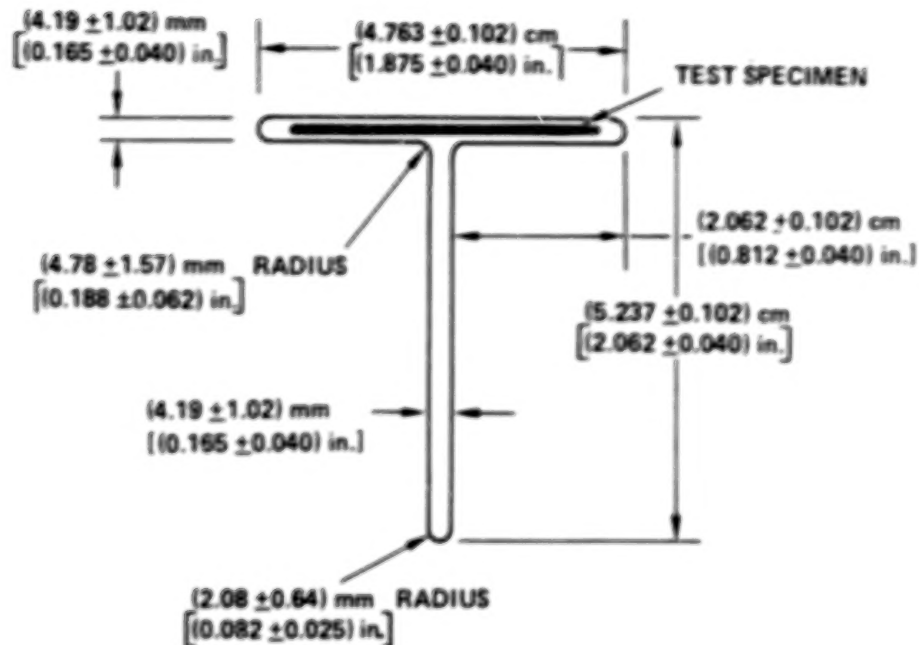
Figure 3. - Shape of Ti-8Al-1Mo-1V and Ti-6Al-4V titanium extrusions.

- (a) 0.38 mm (0.015 in.) MAXIMUM DEPTH OF SURFACE DEFECT.
- (b) 0.63 mm/30 cm (0.025 in./ft) STRAIGHTNESS TOLERANCE.
- (c) 0.10 mm/cm (0.010 in./in.) DEVIATION FROM FLATNESS.
- (d) 1 DEGREE/30 cm (1 DEGREE/ft) TWIST TOLERANCE, NOT TO EXCEED 5 DEGREES FOR ANY TOTAL LENGTH.

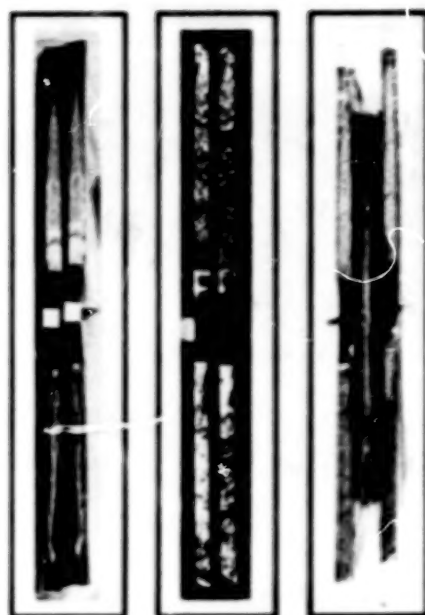
Figure 11. - Photomacrographs showing mating fracture surfaces for mill-annealed Ti-8Al-1Mo-1V sheet specimens.

(a) and (b) failed during real-time testing.  
(c) failed during accelerated testing.

The crack propagation data recorded are given in Tables 5 through 10. Photomacrographs showing the mating fracture surfaces of the failed specimens are given in Figures 11 through 17. No photomacrograph is available for specimen G-1, nor is the specimen available, since it was cut up for metallurgical analysis (see Appendix B).

From Table 4, it is seen that four specimens failed during the real-time testing without a crack being observed. The four specimens were: mill-annealed Ti-8Al-1Mo-1V sheet specimen ET-4, which failed after 54 338 flights; and mill-annealed Ti-8Al-1Mo-1V extrusion specimens H-1, H-2, and H-3, which failed after 22 956, 22 725, and 19 618 flights respectively. Specimens H-2 and H-3 both failed, at different times, when resumption of testing was attempted after a shut-down period during which the specimens were held at small constant tensile stresses at room temperature. It thus appears that mill-annealed Ti-8Al-1Mo-1V extrusion is as notch sensitive as the sheet form of this material, and should be avoided in critical load carrying structure. Further data are required before it can be determined if this material can safely be used.

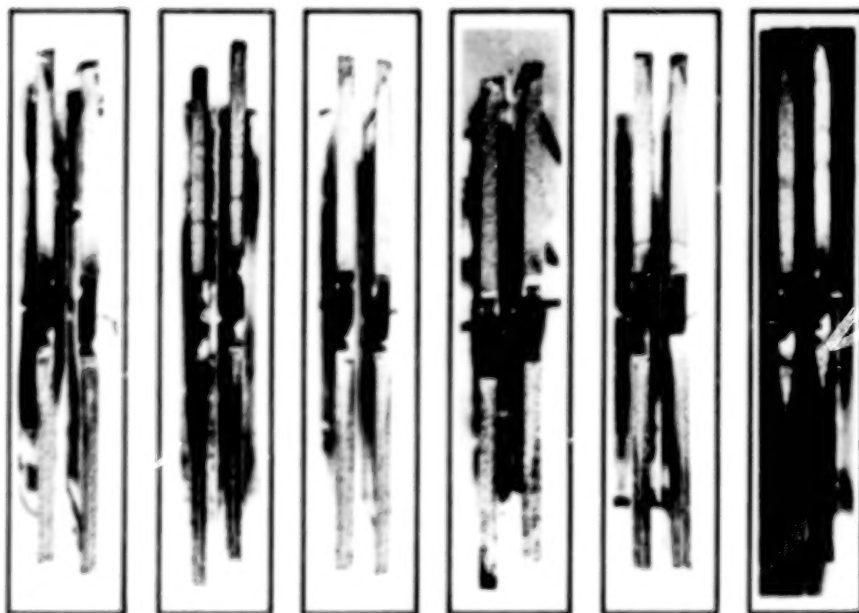
Figure 12. - Photomacrographs showing mating fracture surfaces for duplex-annealed Ti-8Al-1Mo-1V sheet specimens with center notch.

All specimens failed during accelerated testing.

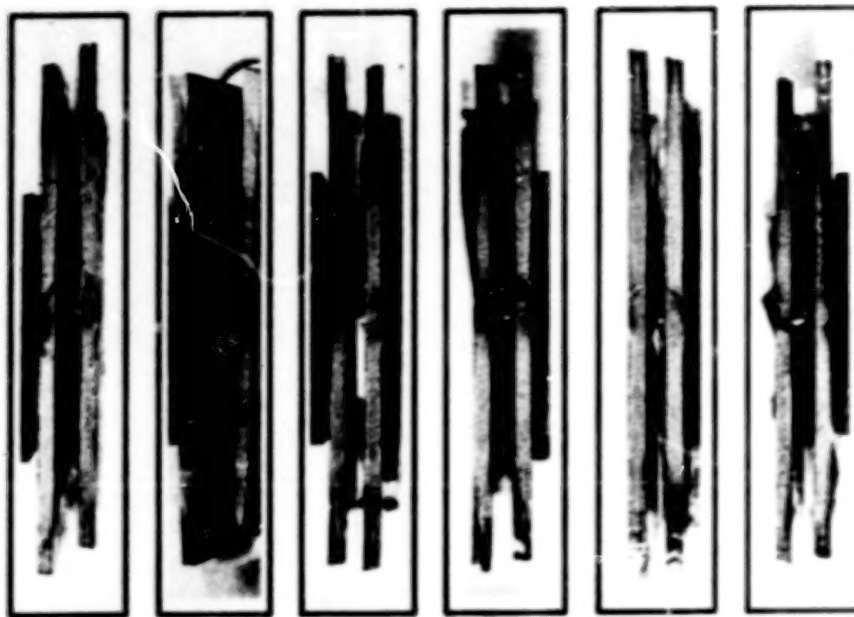
Figure 13. - Photomacrographs showing mating fracture surfaces for duplex-annealed Ti-8Al-1Mo-1V sheet specimens with single spotweld.

(a), (c), (d), (e), and (f) failed during accelerated testing.

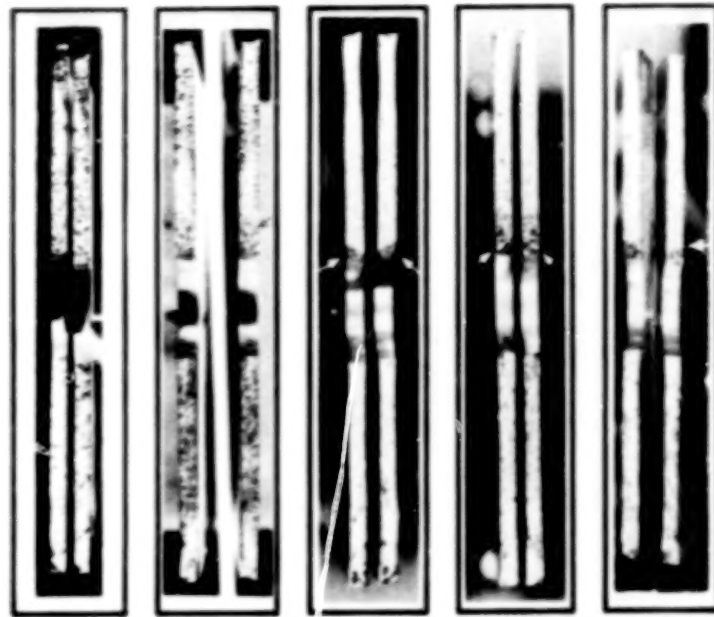
Figure 15. - Photomacrographs showing mating fracture surfaces for mill-annealed Ti-3Al-1Mo-1V extrusion specimens.

All specimens failed during real-time testing.

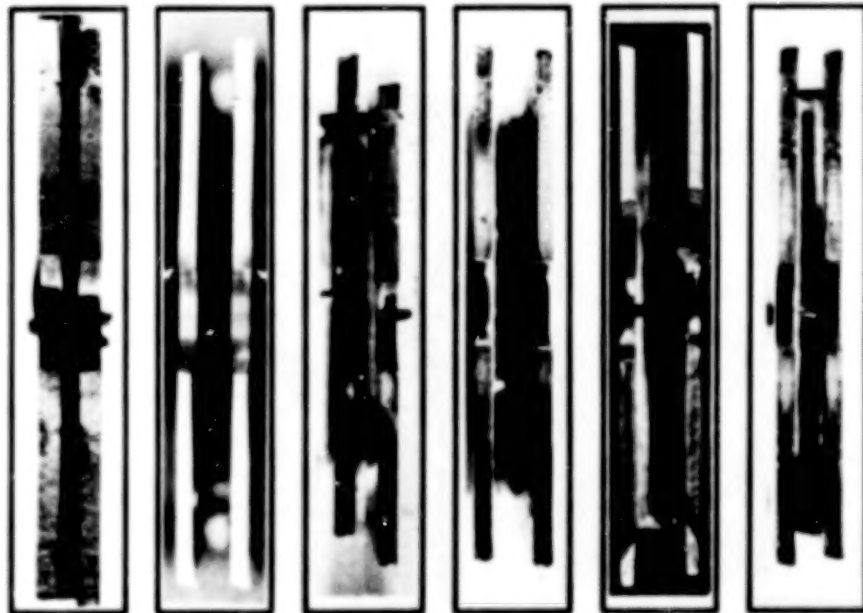
Figure 16. - Photomacrographs showing mating fracture surfaces for mill-annealed Ti-6Al-4V sheet specimens.

(c), (d), and (f) failed during accelerated testing.

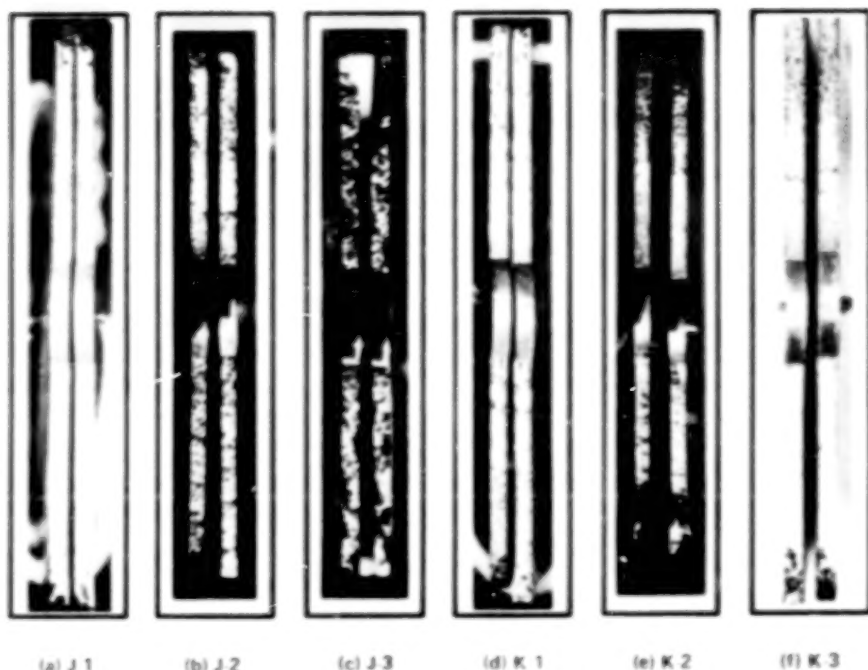
Figure 17. - Photomacrographs showing mating fracture surfaces for solution-treated and aged Ti-6Al-4V extrusion specimens.

All specimens failed during real-time testing.

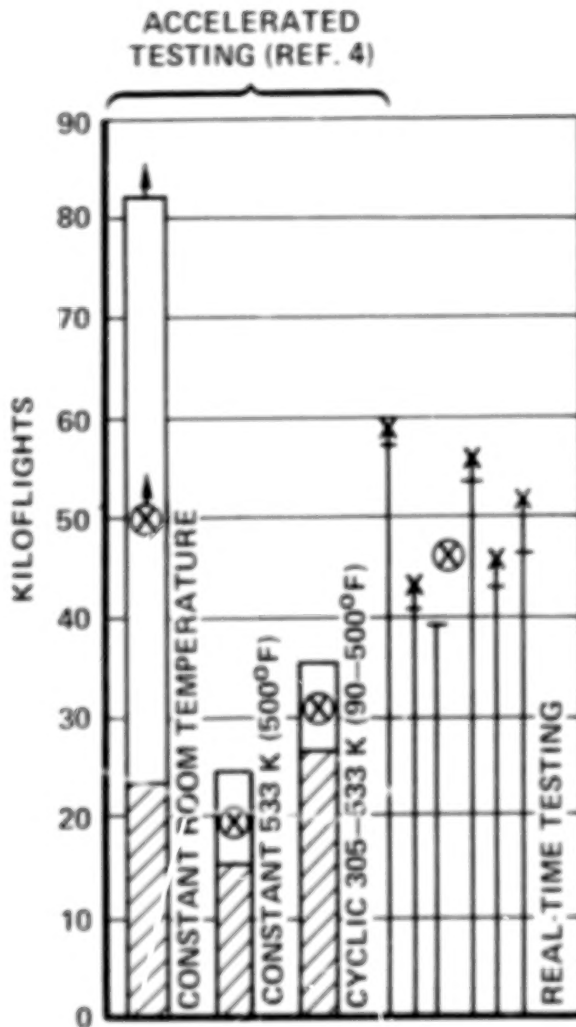
Figure 24. - Comparative test results for solution-treated and aged Ti-6Al-4V extrusion specimens.

THE FOLLOWING SYMBOLS APPLY TO  
FIGURES 18 THROUGH 24.

⊗ LOG AVERAGE OF REAL-TIME  
FLIGHTS AT THE COMPLETION  
OF REAL-TIME TESTING.  
↑ LOG AVERAGE INCLUDES  
UNFAILED SPECIMEN(S).

The real-time test results given in Table 4 have been plotted in Figures 18 through 24. For the fifteen specimens which did not fail during real-time testing, the accelerated test flights have also been plotted. The maximum, minimum, and log average values of the corresponding accelerated test results from Reference 4 have also been given in Figures 18 through 24.

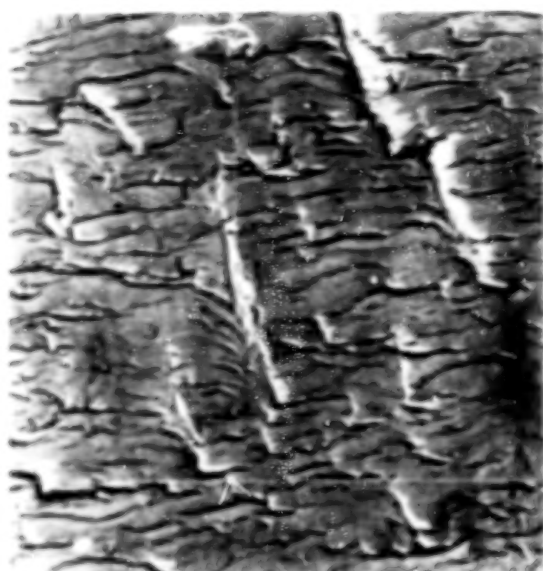
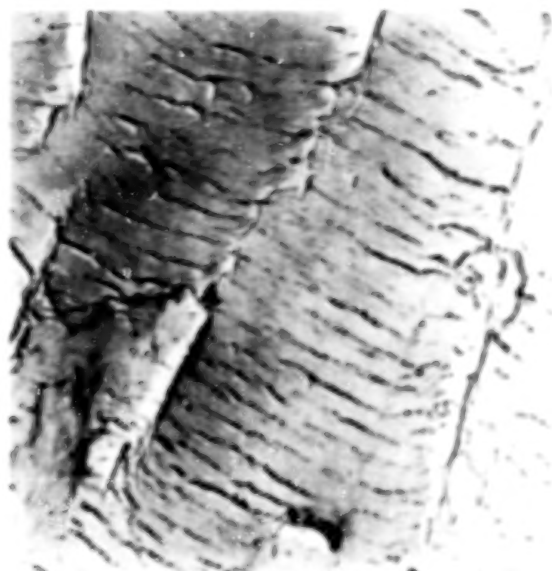
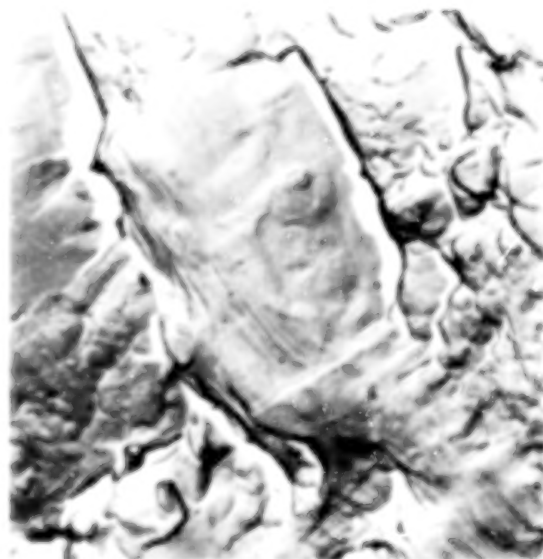
Figure 2. - Electron fractographs from mill-annealed Ti-8Al-1Mo-1V extrusion specimen G-1. Mag. 6500X

(a) and (b) Fatigue striations interrupted by cleavage steps which were predominant in the fatigue regions.

(c) Dimples and second phase particles; and  
(d) Cleavage-type fracture features; in the  
area adjacent to the larger fatigue region.

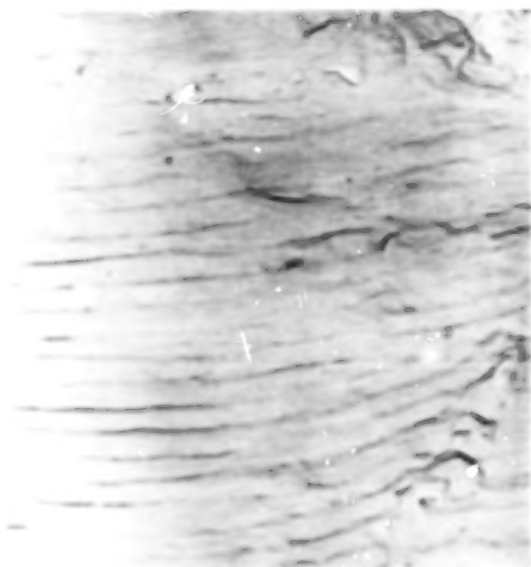
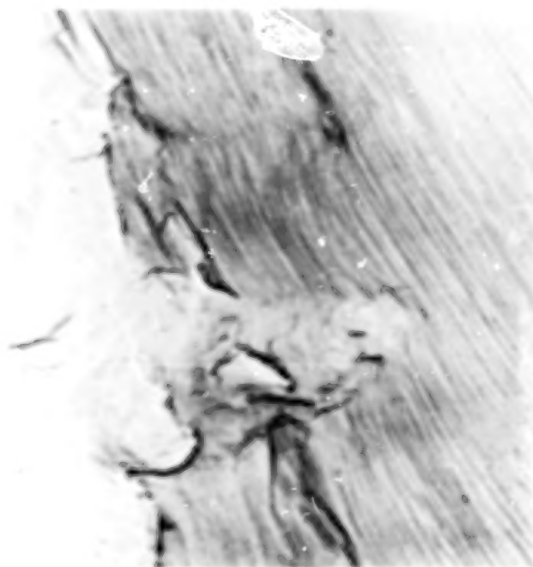
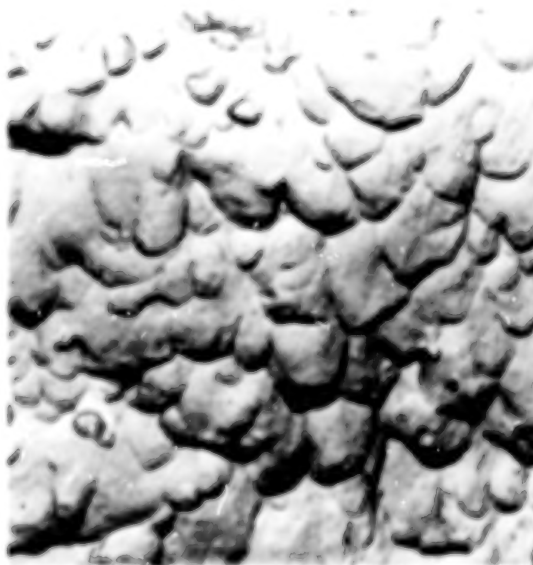
Figure 26. - Electron fractographs from mill-annealed Ti-8Al-1Mo-1V extrusion specimen GL-10. Mag. 6500X

(a) and (b) Well defined fatigue striations with very little cleavage in the fatigue regions.

(c) An isolated area of fatigue striations; and (d) An area of well formed dimples of both equiaxed and elongated types; in the fatigue-to-overload transition regions.

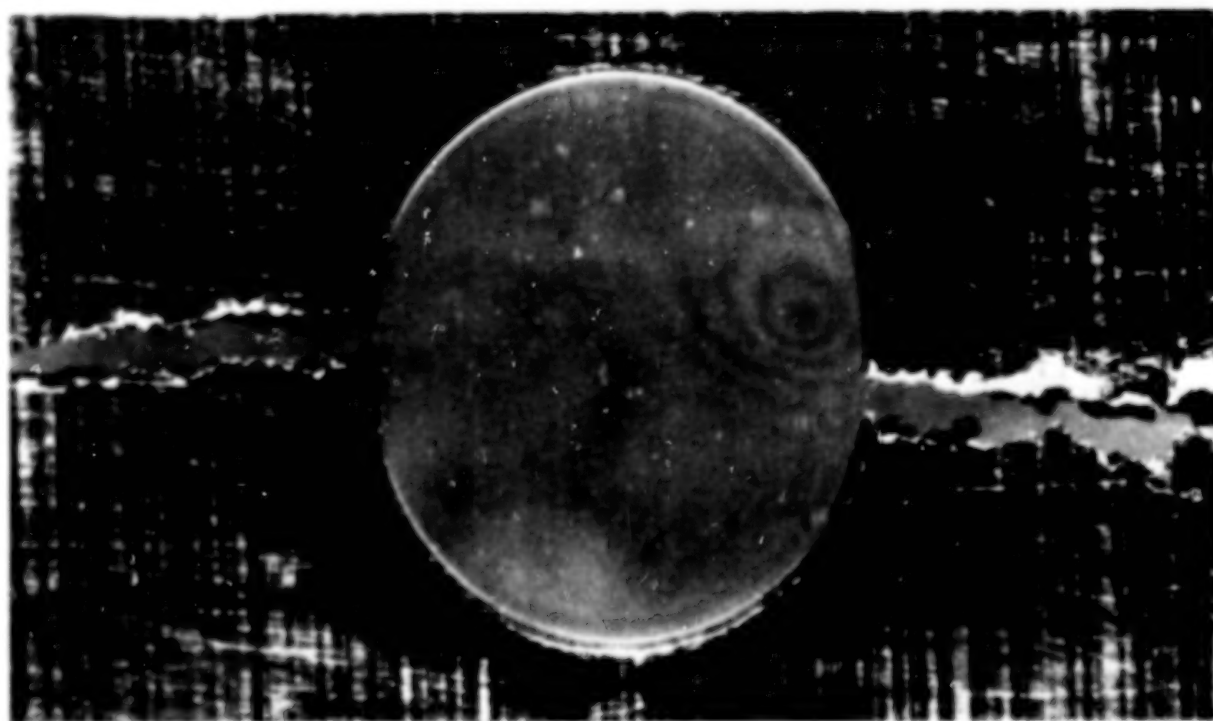
Figure 28. - Photomicrographs of the hole region of mill-annealed Ti-3Al-1Mo-1V extrusion specimen H-3.

(a) The center hole with rough scored surface and raised annular ring. Mag. 8X

(b) The center hole with raised annular ring and deformed radius. Mag. 10X

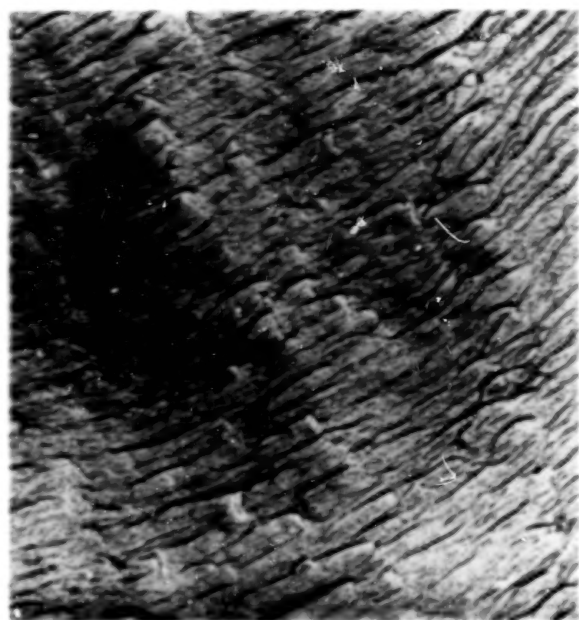
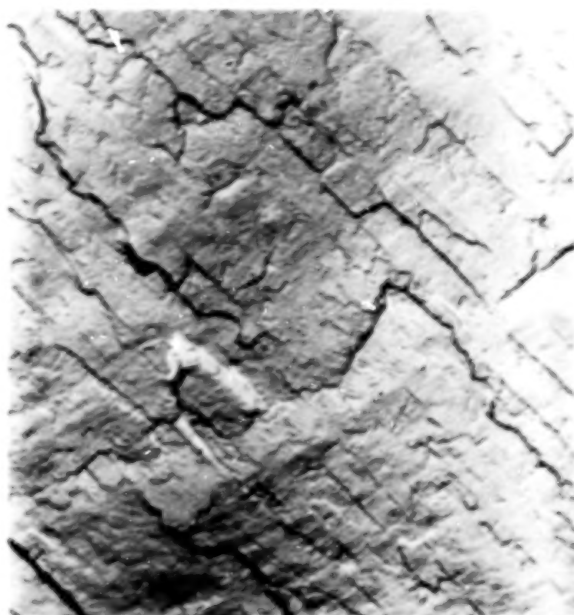
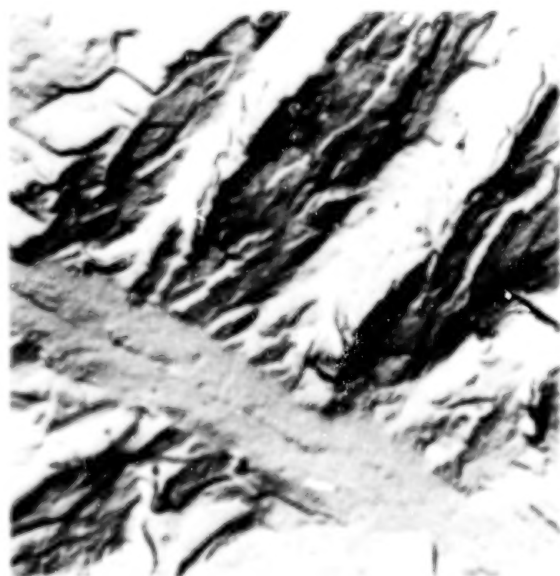
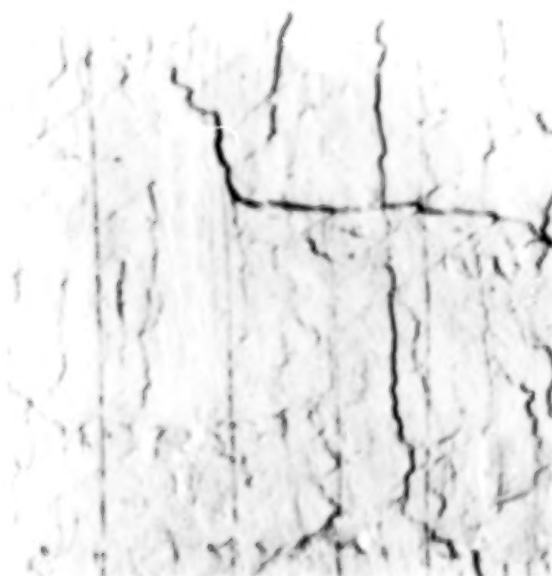
Figure 30. - Electron fractographs from mill-annealed Ti-5Al-1Mo-1V extrusion specimen H-3. Mag. 6500X

(a) Fatigue striations with occasional striation cracking found in the oxidized fatigue area; and (b) Cleavage rupture mode found in the rapid overload failure area.

(c) and (d) Cleavage-type fracture features found intermixed with fatigue striations in the fatigue region.

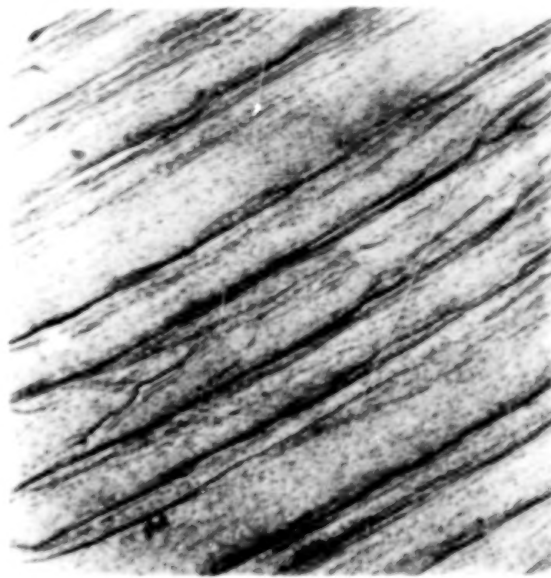
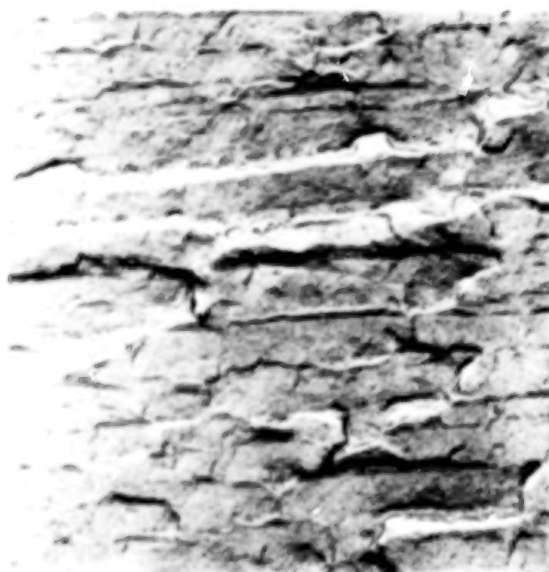
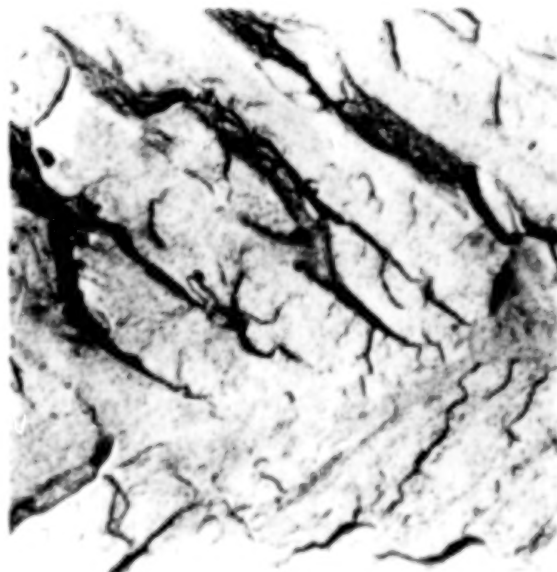
Figure 3C. - Continued.

(e) Fatigue striations interrupted by cleavage steps; and  
 (f) Uninterrupted fatigue striations; in the fatigue region.

Predominant cleavage-type fracture features in an area: (g) Adjacent to the fatigue region; and (h) Half-way towards the specimen outer edge.

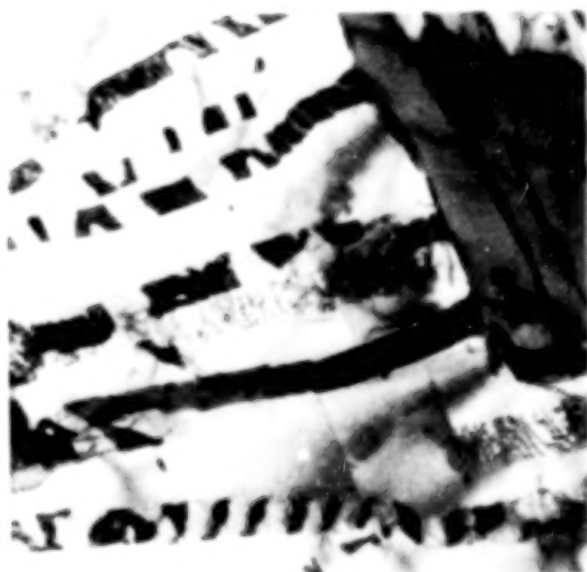
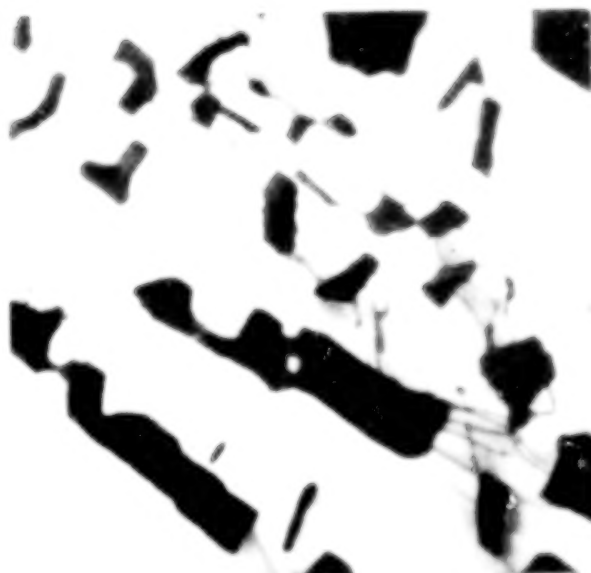
Figure 31. - Transmission electron micrographs from mill annealed Ti-41-11%V extrusion specimen B-3.

(a) Parallel lamellae separated by relatively low angle boundaries with clear grain interiors; and (b) Prominent grain boundary (upper left to lower right) with numerous partial dislocations and associated stacking faults evident in the right grain.

(c) Parts of two grains with stacking faults and several dislocation pile-ups; and (d) High magnification electron micrograph of areas with a parent second phase particles interconnected by dislocations.

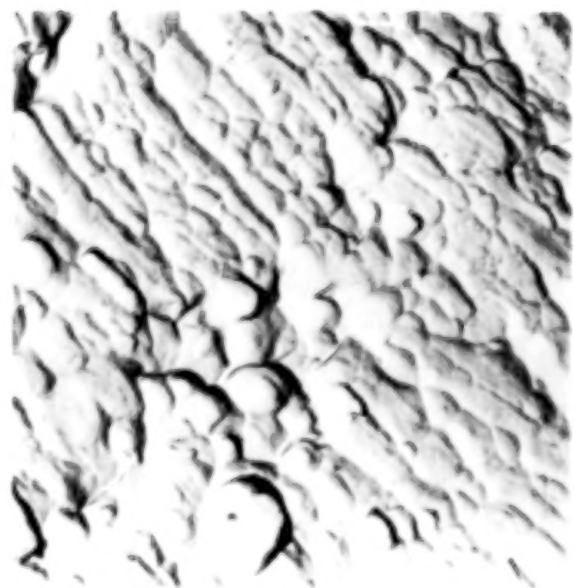
(a) Fatigue striations interrupted by cleavage steps; and  
(b) Cleavage-type fracture; in the fatigue region.

(c) and (d) Well formed dimples of both equiaxed and elongated types in the overload region.
